## **Evaluation of the Tekscan F-SCAN system for measurement of the kicking force in horses**

Journal Article

# Evaluation of the Tekscan F-SCAN system for measurement of the kicking force in horses

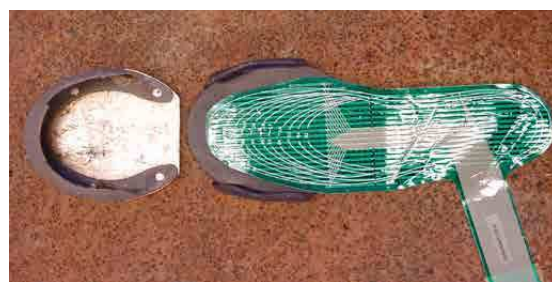
Fig. 1: Tekscan F-SCAN and the horseshoe system prepared for measuring the force of a kick.

The Tekscan F-SCAN system is an in-shoe pressure measuring system that has been used primarily for gait analysis on treadmills in human kinetics. It uses ultra-thin plastic sensors in the shape of a human foot. Each sensor contains 960 piezoelectric elements composed of quartz crystals, which generate an electric current when deformed. The amplitude of the electric current is proportional to the force applied to the sensors and can be amplified and displayed on a computer. Piezoelectric measuring systems are very sensitive over a wide range of forces and also can be used to measure the heart rate of a standing person or the impact on a dummy during

an automobile crash (McLaughlin et al., 1996; Young, 1993). Only the front part of the sensor (from the toe to the arch of the foot) was used to record the force of a kick because this region fits the sole of the hoof. Each sensor was placed between two 2-mm plastic pads, which were incorporated into a custom-made horseshoe (Fig. 1). A sensor-shoe combination was attached to each hind foot to measure the force of the kicking limb and the stance phase of the non-kicking limb (Fig. 2). The sensors were connected to a converter, which was fastened to the fetlock with Velcro. The measuring system was connected via a 10-m cable and a 16-bit receiver card to a microcomputer with the corresponding pressure and force measurement software program. To obtain meaningful measurements, the Tekscan sensors must be calibrated to the anticipated pressure range (Brimacombe et al., 2009). Therefore, before obtaining any force measurements, each sensor was individually calibrated with the previously recorded weight borne by the hind limbs with the horse standing square.

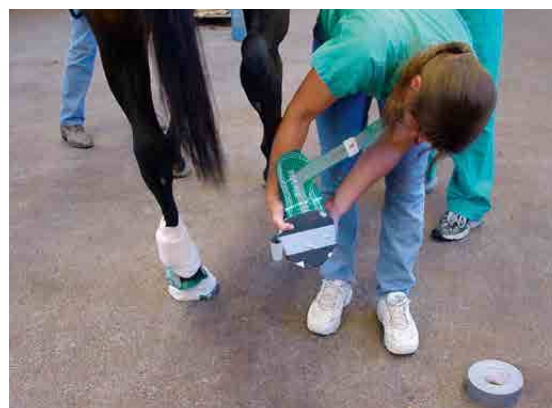
Fig. 2: The sensor and specialized shoe are attached to the sole of the foot.

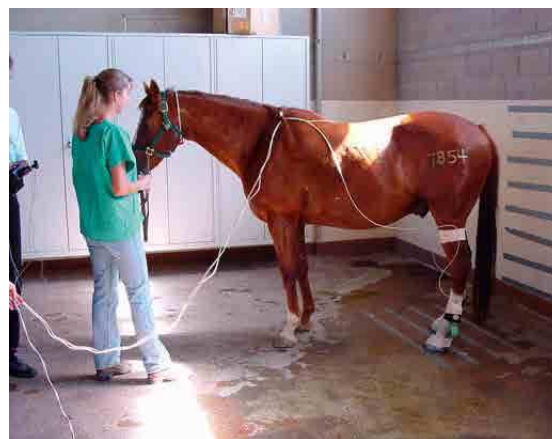
Fig. 3: The horse is placed with its hind end toward a cement wall.

All horses were restrained using a halter and lead shank and placed with their hind end towards a cement wall. The distance between the wall and the back hooves was 40 to 50 cm, depending on the length of the hind legs of each horse, to make sure that the horse did not miss the wall when kicking. Strips of tape were placed 20 cm apart on both the floor and the wall so that the distance between the horse and the wall and the site of contact between the hoof and the wall could be determined (Fig. 3). This was achieved by recording each kicking event with a video camera. All kicks were evaluated subjectively based on the speed and severity of the kick and the noise created by the impact of the foot against the cement wall and graded on a scale from 1 (weak) to 5 (very strong).

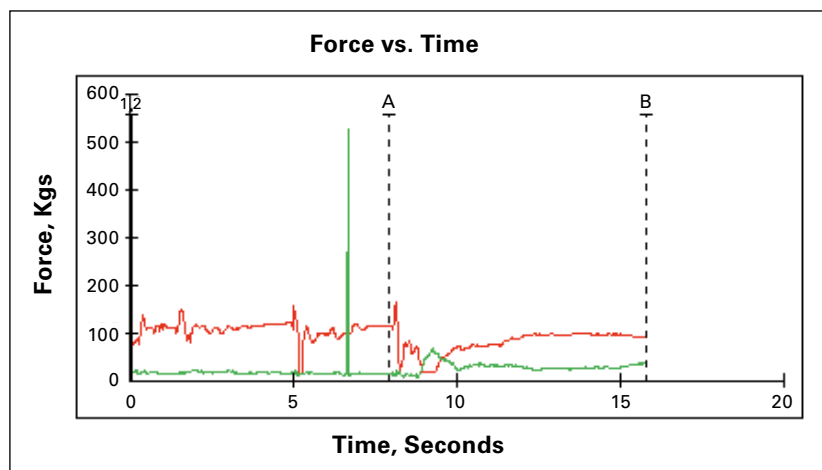
Fig. 4: Force-versus-time recording of the kicking (green) and non-kicking (red) hind limbs of a horse while kicking a wall.

A total of 80 frames per second were recorded for a period of 10 seconds, which yielded a total of 800 frames for data analysis. The force curve was compared with the video footage to determine the moment of kicking. The force of a kick was then derived from the force-versus-time graph (Fig. 4). The force recorded from kicks of the left and right hind limbs ranged from 1'413 to 3'333 N ( $2'476 \pm 717$  N). The force on the weight-bearing hind limb during kicking was also measured and ranged from 325 to 7'805 N ( $3'041 \pm 2'138$  N). A total of 10 kicks could be analysed, and in 9 cases, data of both hind legs could be assessed. The results are shown in Table 2.

The measured forces of the kicks in this study ranged from 1'413 to 3'333 N. Interestingly, during kicking, the force measured in the weight-bearing limb exceeded the force delivered by the kicking limb in 6 of 9 cases, in which forces on both hind legs could be measured. The mean kicking force was lower than that recorded in horses trotting on a treadmill (Judy et al., 2001), in which the forces exerted on one limb were similar to the horse's body weight. The reason for the lower force of a kick may be related to the measuring technique used. The sensors generated the sum of all forces acting on the limb, and this force was often higher in the weight-bearing limb because all sensors were activated simultaneously. In contrast, because the sensor plate did not extend to the weight-bearing part of the hoof wall, and in many instances the kicking hoof hit the wall at an angle, the resultant total force was lower in the kicking limb. The technique used to attach the sensors to the hoof also may have altered the measurements because of shear forces (Perino et al., 2007). Another reason for the low measured forces may have been reluctance of the horse to kick the concrete wall a second time. The major difficulty in this study was induction of a consistent kick response. Irrespective of the method used, only the first stimulus induced kicking in some of the horses. After a maximum of four attempts, the horses reacted by moving forward instead of kicking, possibly because they became accustomed to the procedure of stimulation or kicking a cement wall elicited pain.
